# Parappa

NEWSLETTER OF THE BOAT "PARAPPA" ISSN 1835-4548 No. 8. FEBRUARY 2011

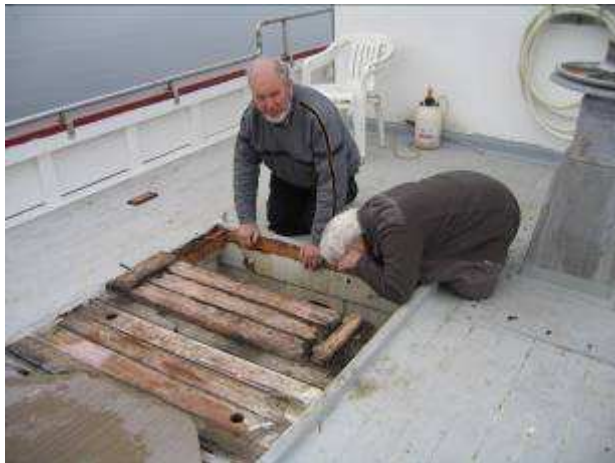
*Des Beechey and Irene Briant inspecting the well in August 2004*

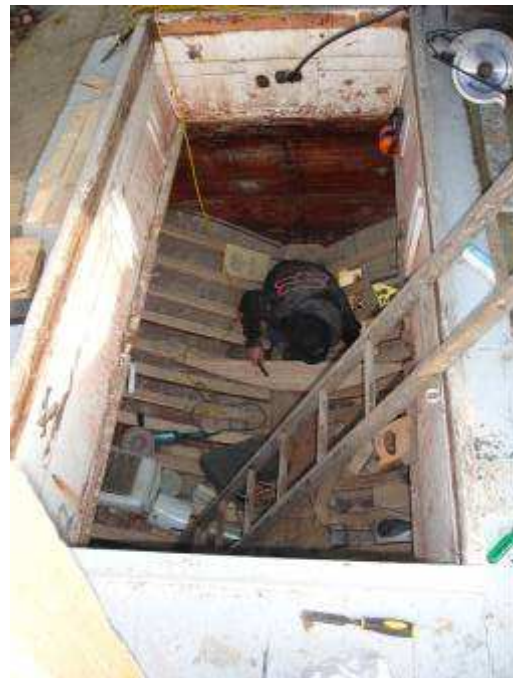
*A new keel top, more ribs and new floors were installed in the well.*

The 96 holes providing sea water circulation were closed with wooden plugs, but it was discovered that they were not the only, perhaps not even the major, source of sea water for the well. Over the years the junction between the bottom hull plank on each side of the keel had opened up, partly because of deterioration of the planks and partly because of crayfish

scrapping away at the timber. The bottom of the well had been lined with a few inches of concrete, possibly for ballast, but most likely to provide protection to the timber from crayfish.

Extensive work on the keel and hull timbers was needed to make the well properly watertight. The top three inches (75 mm) of deteriorated keel timber was removed and a new keel top glued into place. Sections of the lower hull planks that were supposed to meet the keel were replaced to give good, tight joins. And new floor timbers were installed ("floors" are timbers that support the floor we stand on).

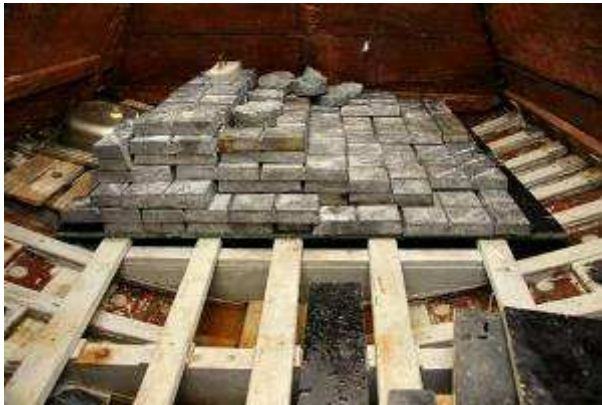
*Five tonnes of lead ballast was needed in the well to compensate for increased buoyancy*

With closure of the well, the buoyancy of the vessel increased substantially. When the sea was able to circulate through the well, the volume of the well did not contribute at all to making the boat float. But when the sea was excluded there was an additional air space inside the hull providing buoyancy, and the boat floated about 12 inches (300 mm) higher in the water. To counteract this, 5 tonnes of lead ballast was placed in the well, supported by the new strengthened floors. As the weight of the new wheelhouse put the trim down at the stern, most of this ballast was placed at the front of the well.

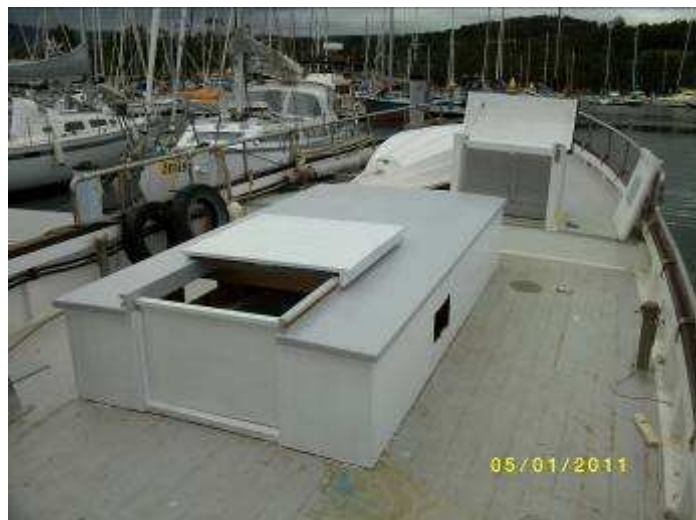
*The new deckhouse over the well. Windows are yet to be put into the sides.*

Conversion of the well has been completed in January 2011 with the building of a deckhouse over the well, to create a dry working space. The deckhouse is raised only about 18 inches (450 mm) above the deck, giving adequate headroom inside, but not impacting on the general appearance of the boat. It was built with a frame of 50 x 100 mm hardwood, with a roof of 120 x 35 mm hardwood planks. These were jointed with Sikaflex seams, giving an appearance the same as the existing deck. The sides were panelled with 13 mm thick vertical jointed hardwood, to match the existing vertical face at the rear of the fo'c'sle. All was painted in the same colours as the existing deck and wheelhouse.
