# Parappa

NEWSLETTER OF THE BOAT "PARAPPA" ISSN 1835-4548 No. 8. FEBRUARY 2011

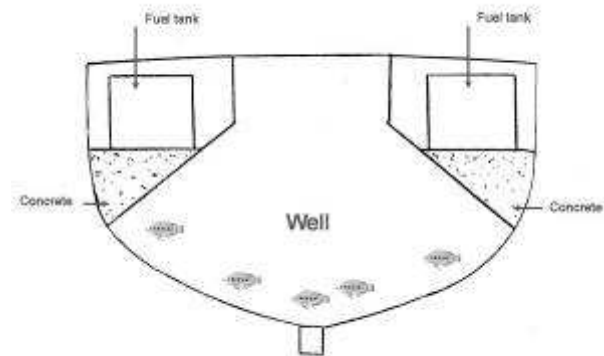
*Cross section of the hull amidships, showing the location of the well.*

above. Between the well and the outer hull is concrete ballast, with fuel and water tanks on top.
